Limited Asbestos and Hazardous Materials Survey Report

**Ralph M. T. Johnson School and
Anna H. Rockwell Elementary School**

**Bethel, Connecticut
May 9, 2017**

**RE: Limited Asbestos and Hazardous Materials Survey Report
Ralph M. T. Johnson School and Anna H. Rockwell Elementary School
Bethel, Connecticut
MMI #4494-08-03**

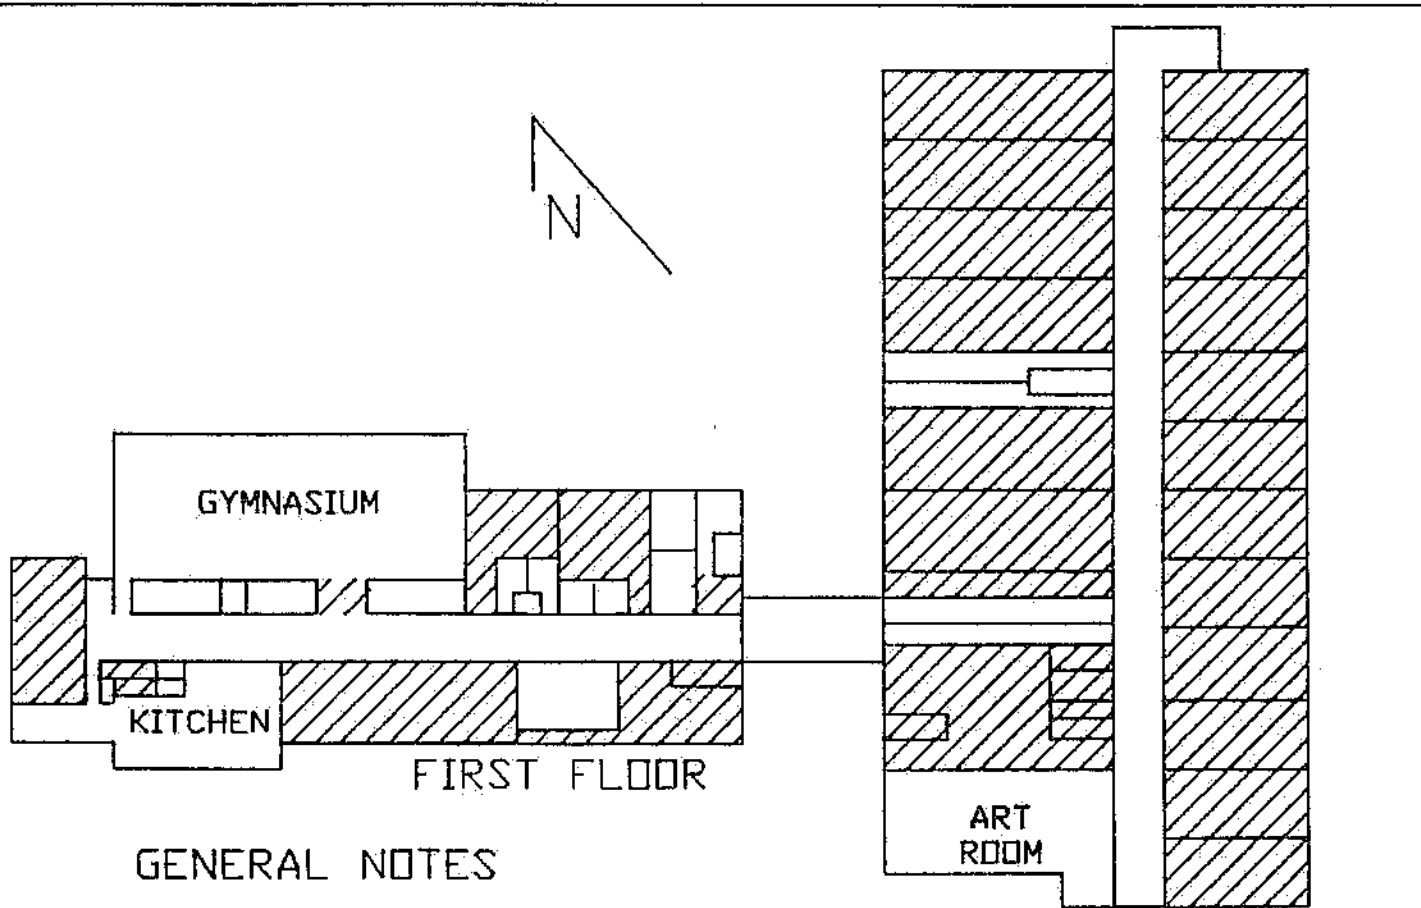
TRC Environmental Consultants, Inc.		An Equal Opportunity Employer M/F/V/H	
ASBESTOS BULK SAMPLING			
FIRST FLOOR JOHNSON SCHOOL BETHEL, CT			
PREPARED BY	DATE	SCALE	PROJECT NO.
BLANK	8/11	ASIS	6040101
APPROVED	8/11	DATE	SCALE
		ASIS	1

THE ONLY ASBESTOS-CONTAINING MATERIAL FOUND ON THIS FLOOR OF THE SCHOOL IS IN THE FORM OF NONFRIABLE FLOOR TILE (HATCHED AREA). THIS MATERIAL WAS NOT SAMPLED BECAUSE THE STATE OF CT CONSIDERS ALL RESILIENT FLOORING TO BE "NONFRIABLE ACM".

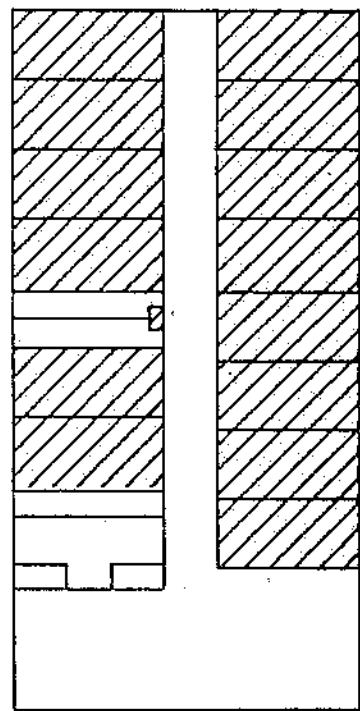
TRC		Environmental Consultants, Inc.	60 Broad Street New Haven, Connecticut 06510
ASBESTOS BULK SAMPLING			
SECOND FLOOR JOHNSON SCHOOL BETHEL, CT			
DEVELOPER		DATE	FIELD NO.
OWNER	EH	6/10	000001
APPROVER		DATE	FIELD NO.
		4/20	0

THE ONLY ASBESTOS-CONTAINING MATERIAL FOUND ON THIS FLOOR IS IN THE FORM OF NONFRIABLE FLOOR TILE (HATCHED AREA). THIS MATERIAL WAS NOT SAMPLED BECAUSE THE STATE OF CT CONSIDERS ALL RESILIENT FLOORING TO BE "NONFRIABLE ACM".
