Building Conditions Investigations Report

Anna H. Rockwell Elementary School:
400 Whittlesey Drive
Bethel, CT

Mechanical and Electrical Systems
Existing Conditions Narrative

Anna H. Rockwell School
Bethel, Connecticut
June 27, 2011

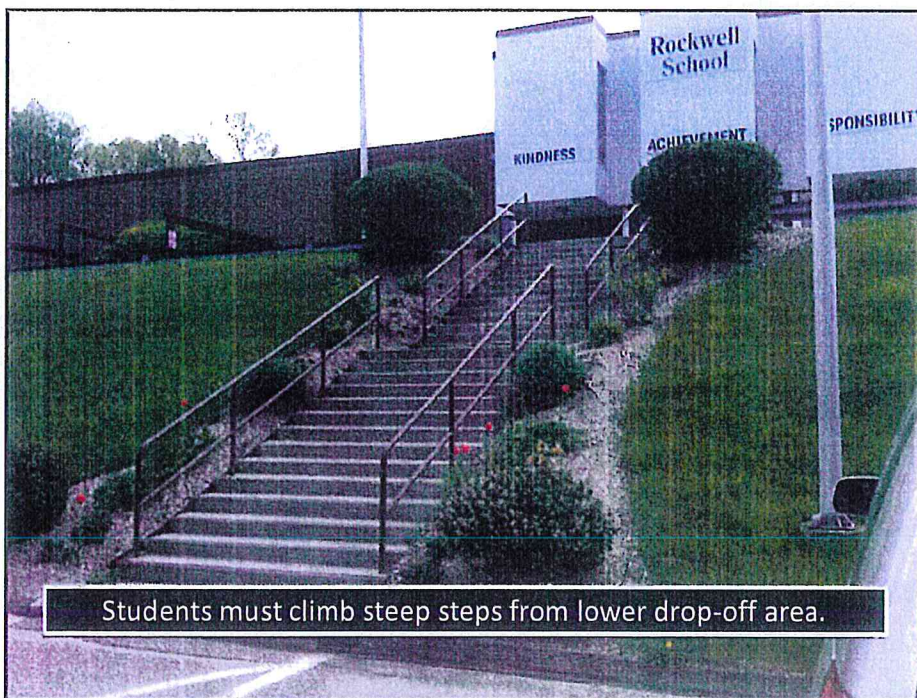
Students must climb steep steps from lower drop-off area.

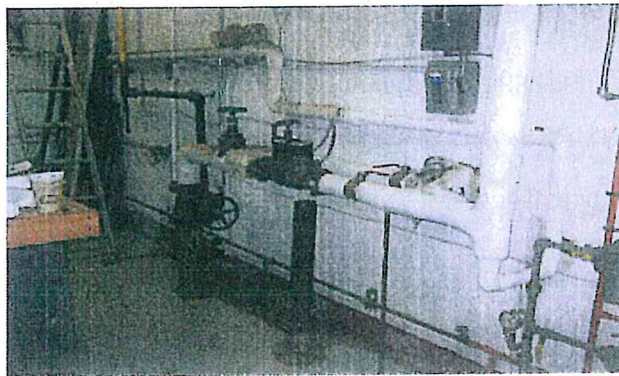
- a. Existing Domestic Water Service: The existing building is currently served by a 3 inch domestic water service. The domestic water service equipment includes a 2 inch water meter and isolation valves. This water service currently serves all of the Schools domestic water needs and has adequate pressure. The water distribution system is original to the building.

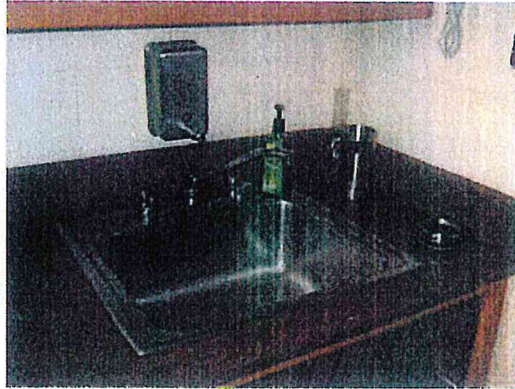
- Stainless steel sinks with kitchen type faucets are used in various locations, such as faculty work rooms, etc. These sinks are non-ADA compliant and in fair condition.

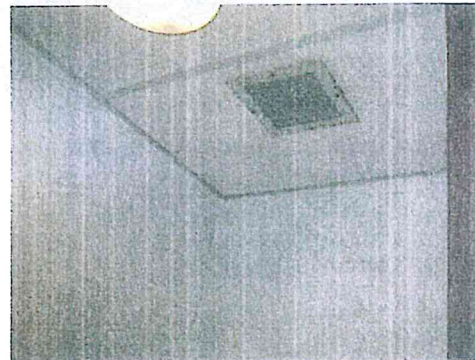
2. The present Heating and Ventilating systems consist of hot water finned tube radiation, hot water convectors, unit ventilators, window unit air conditioning units and exhaust systems. The mechanical equipment is located primarily in various indoor hallways, rooms and areas throughout the building. Exhaust fans air components are located on the roof. Air-handling units have hot water heating coils, filter sections, and exhaust fans. Exhaust ductwork is located above the ceilings.

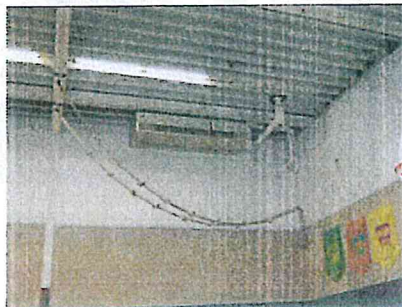
3. Gymnasium heating consists of air-handling units with hot water heating coils and roof mounted exhaust fans for ventilation.

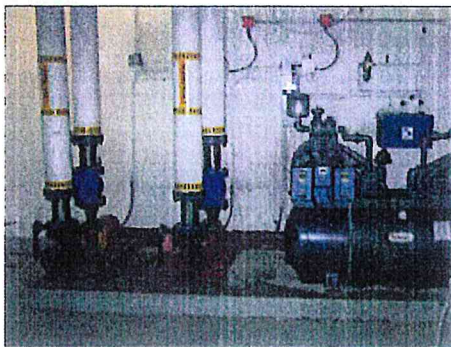
10. The existing temperature controls in the school are pneumatic. The temperature control system air compressor is located in the boiler room and includes a dryer. There have been problems reported with air leaks associated with this system causing erratic operation. The building also has an Invensys control system with a graphical interface that is web based.
