Limited Asbestos and Hazardous Materials Survey Report

**Ralph M. T. Johnson School and
Anna H. Rockwell Elementary School**

**Bethel, Connecticut
May 9, 2017**

**RE: Limited Asbestos and Hazardous Materials Survey Report
Ralph M. T. Johnson School and Anna H. Rockwell Elementary School
Bethel, Connecticut
MMI #4494-08-03**

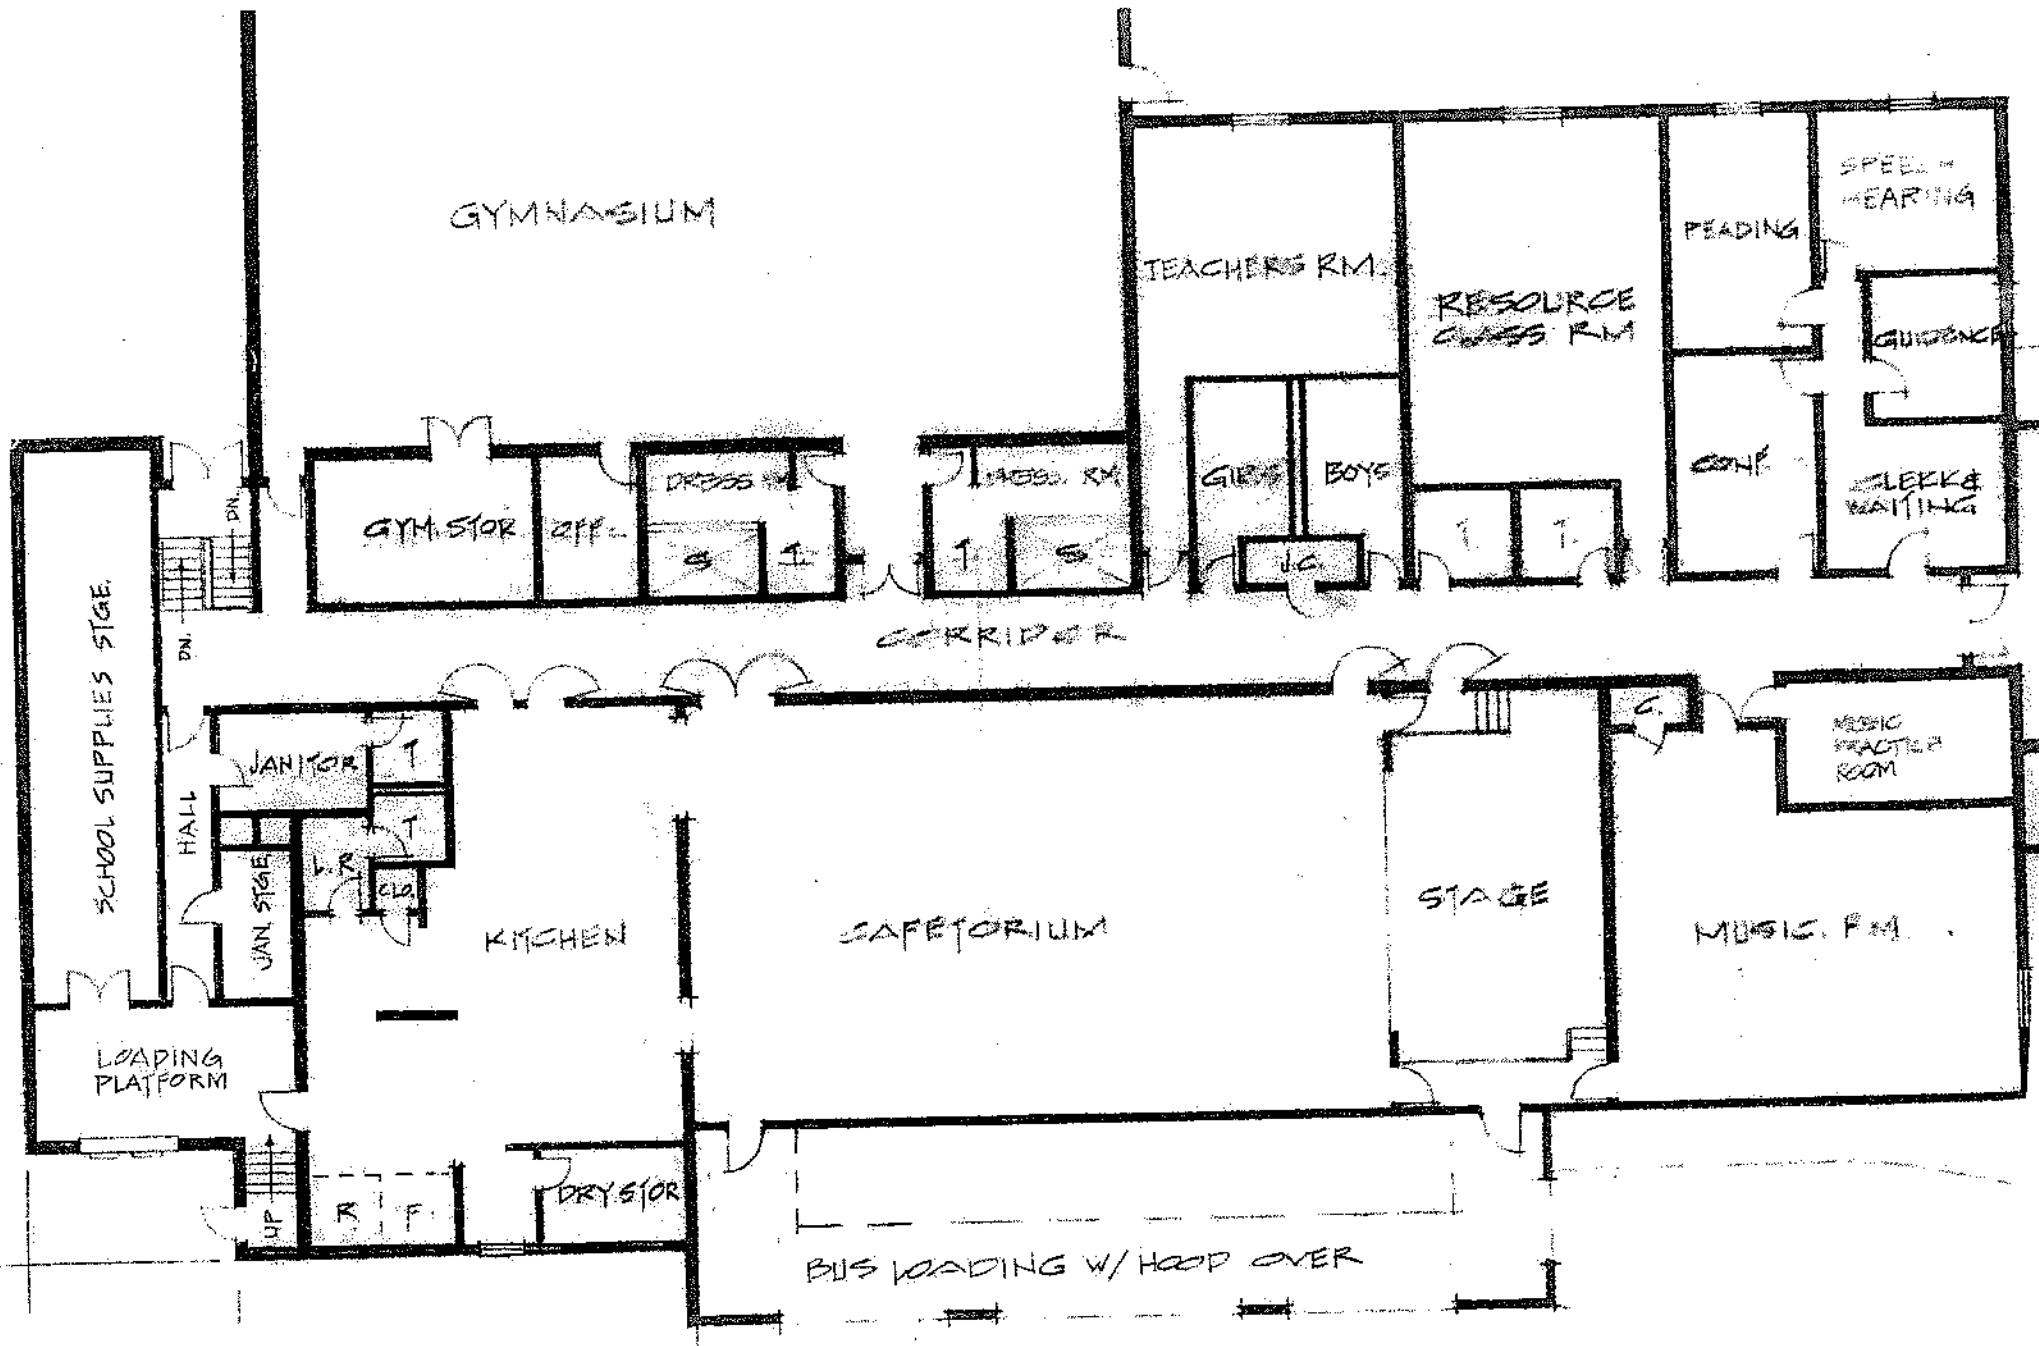
TRC		Environmental Consultants, Inc.	60 Broad Street New Haven, Connecticut 06510
ASBESTOS BULK SAMPLING			
SECOND FLOOR JOHNSON SCHOOL BETHEL, CT			
DEVELOPER		DATE	FIELD NO.
OWNER	EH	6/10	000001
APPROVER		DATE	FIELD NO.
		4/20	0

THE ONLY ASBESTOS-CONTAINING MATERIAL FOUND ON THIS FLOOR IS IN THE FORM OF NONFRIABLE FLOOR TILE (HATCHED AREA). THIS MATERIAL WAS NOT SAMPLED BECAUSE THE STATE OF CT CONSIDERS ALL RESILIENT FLOORING TO BE "NONFRIABLE ACM".
